Manhole Inspection Summary

Manhole # S33G__006MH

Insp Date: **8/14/08 11:34 AM**

Location Address: **20 n hanover st**

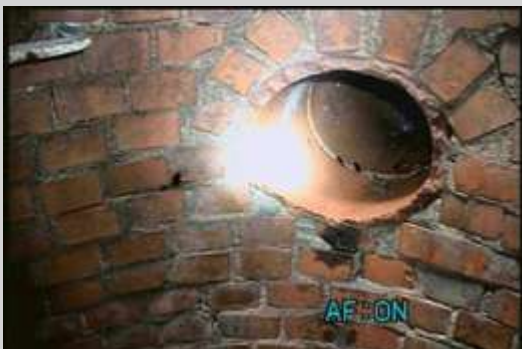
5 O'Clock Inflow

8 in. Circular Gravity Sewer
Pipe In @ 5 OClock

Invert Depth: 11.16 (ft.) Flow Characteristics: Fast

Infiltration: None Pipe Seal Cond: Unknown

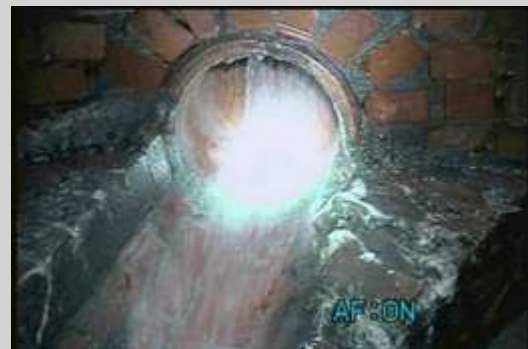
Drop In @ 5 OClock

Drop: Outside Direct

Inv Depth: 18.33 (ft.)

Drop Condition: Open

Connects To: House connection / Service line

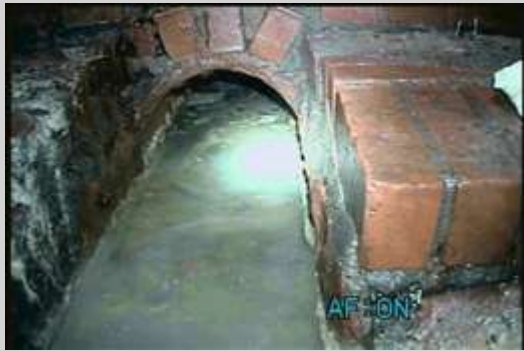
6 O'Clock Inflow

10 in. Circular Gravity Sewer
Pipe In @ 6 O'Clock

Invert Depth: **19.25** (ft.) Flow Characteristics: **Slow**

Infiltration: **None** Pipe Seal Cond: **Unknown**

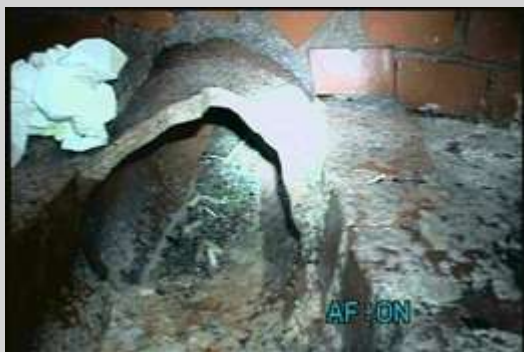
9 O'Clock Inflow

8 in. Circular Gravity Sewer
Pipe In @ 9 O'Clock

Infiltration: **None** Pipe Seal Cond: **Unknown**
